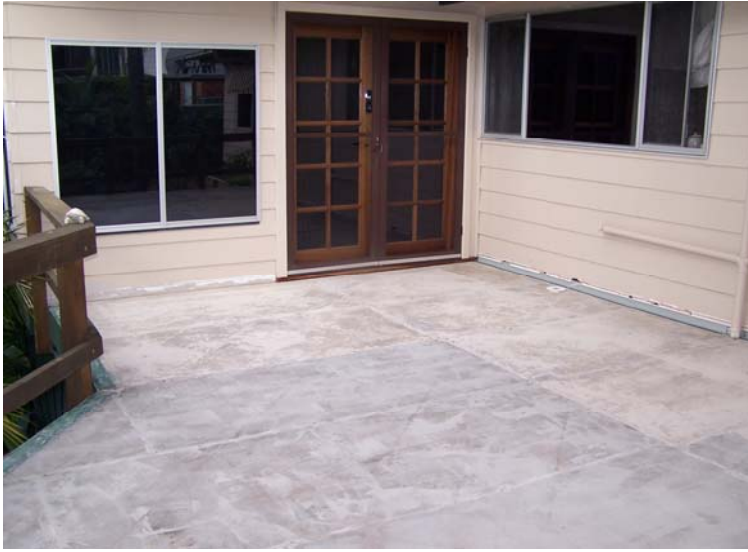
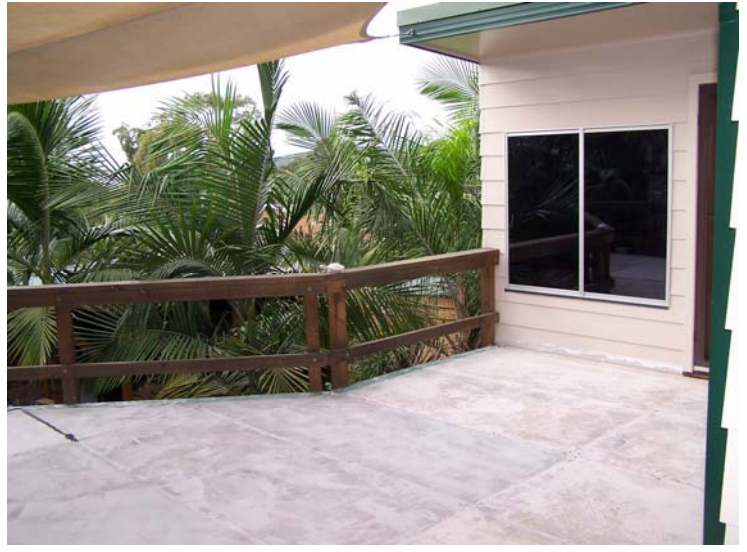
## Before

**This deck was covered with outdoor tiles on it but the owners found that they were cracking with the movement of the footings which was causing leaks into there entertaining area. We removed the tile and excess grout from the compressed fibrous cement. We then primed and sprayed the area with Duraspray with a 36-grit alox for a slip resistant finish and a concrete grey topcoat.**
