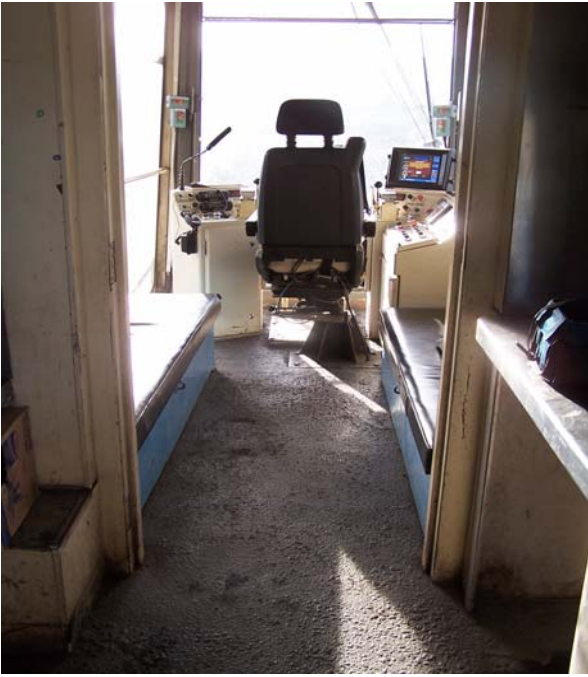
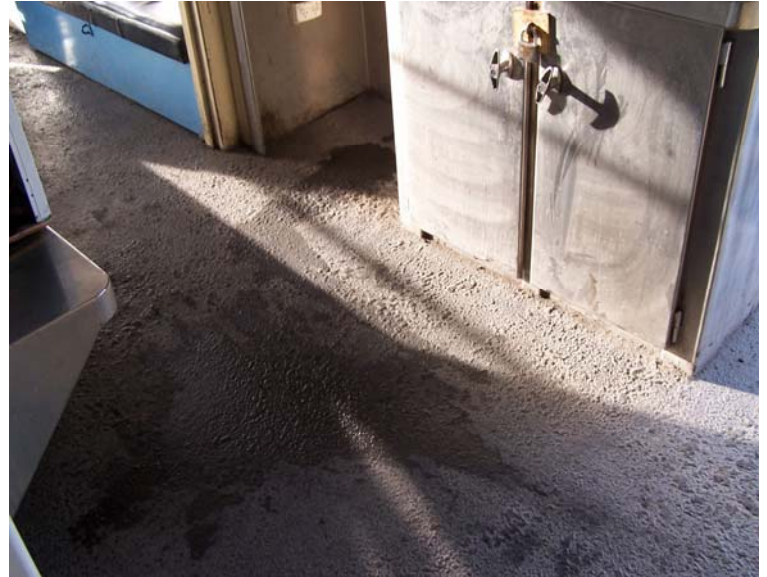
Before

This is dragline floor in a local coal mine. It had a surface that was very hard to maintain, lifting up and was slippery when it was cleaned. We sprayed the floor in Duraspray and added a 36-grit aggregate for a slip resistant finish.
