Here we have a commercial kitchen at Wangi.

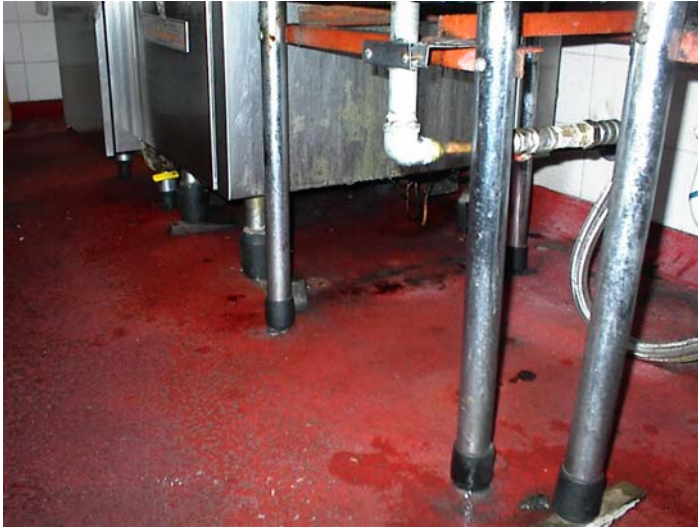
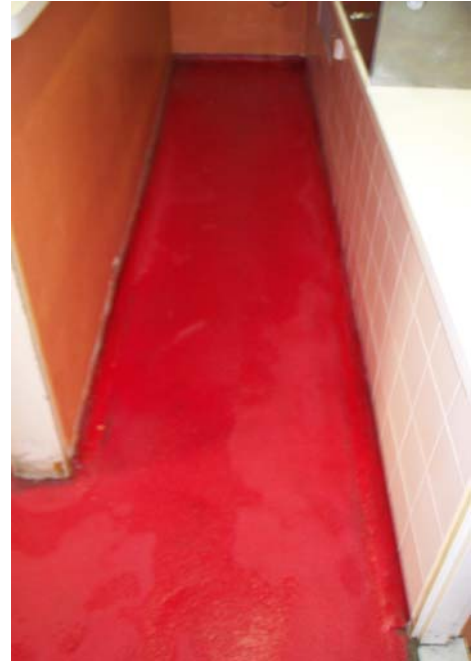
Before

There was an existing epoxy floor in poor condition that needed rejuvenating.
