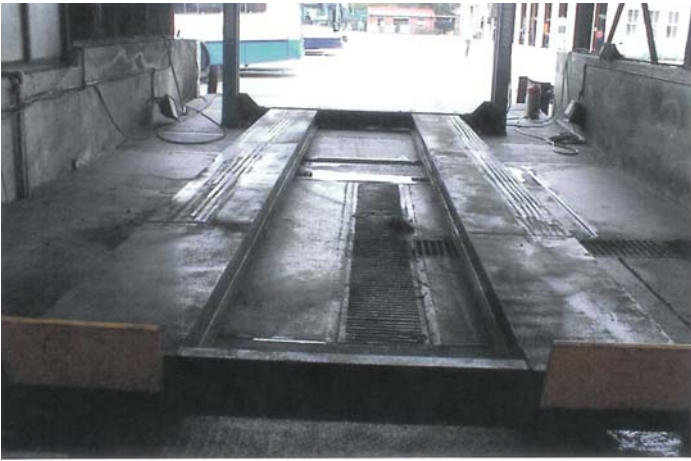
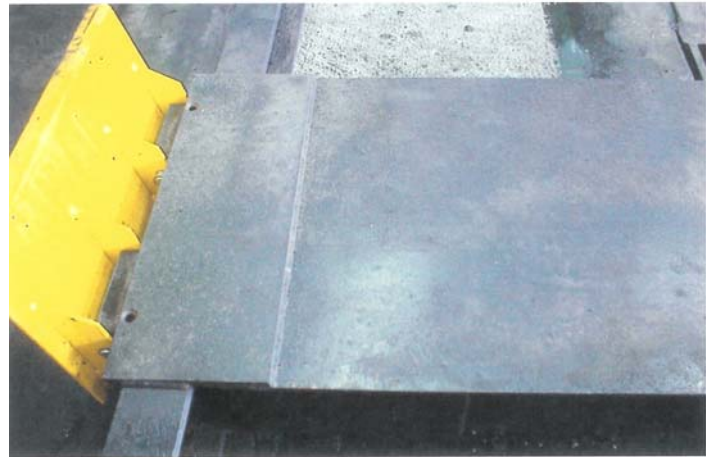
## Before

**This ramp was found to be dangerous, employees were required to wash their bus after each shift with a pressure cleaner and grease remover, as they would remove the bus from the ramp they found that the front wheels would lock up and begin to slide off the ramp. We sprayed the ramp with Durabond and added 24 Aloxx grit for a slip resistant finish. The job took 1 day to complete.**
