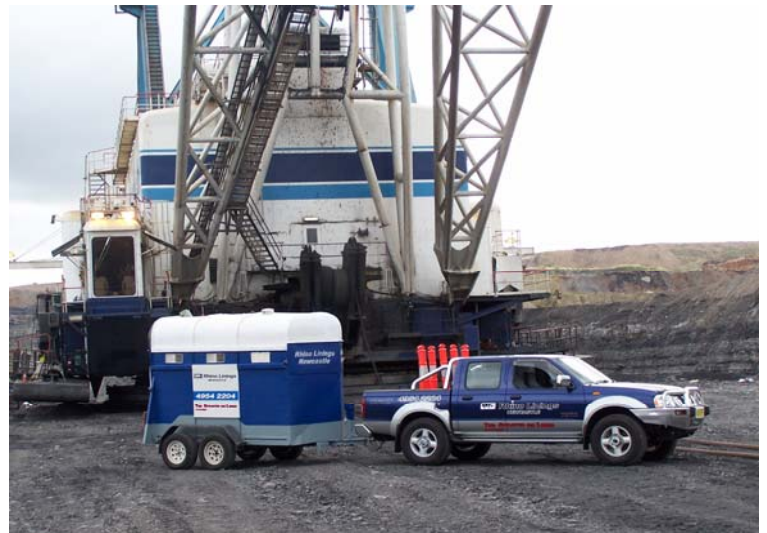
This is dragline floor in a local coal mine. It had a surface that was very hard to maintain, lifting up and was slippery when it was cleaned. We sprayed the floor in Duraspray and added a 36-grit aggregate for a slip resistant finish.
