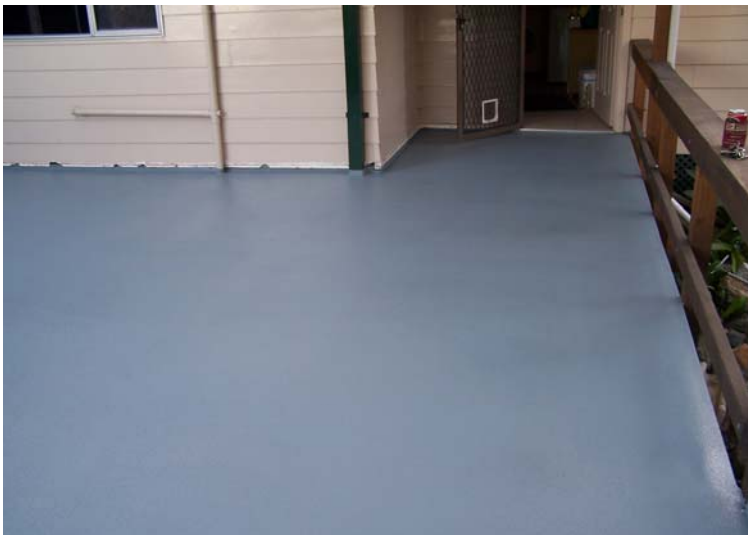
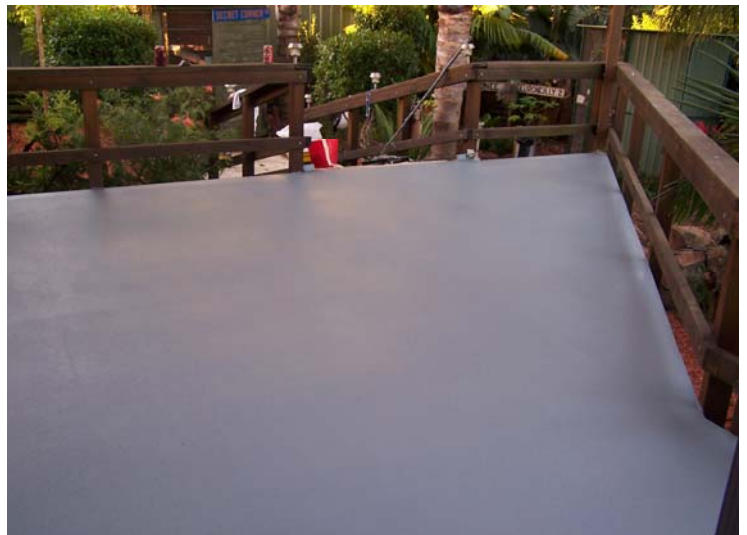
**This deck was covered with outdoor tiles on it but the owners found that they were cracking with the movement of the footings which was causing leaks into there entertaining area. We removed the tile and excess grout from the compressed fibrous cement. We then primed and sprayed the area with Duraspray with a 36-grit alox for a slip resistant finish and a concrete grey topcoat.**
