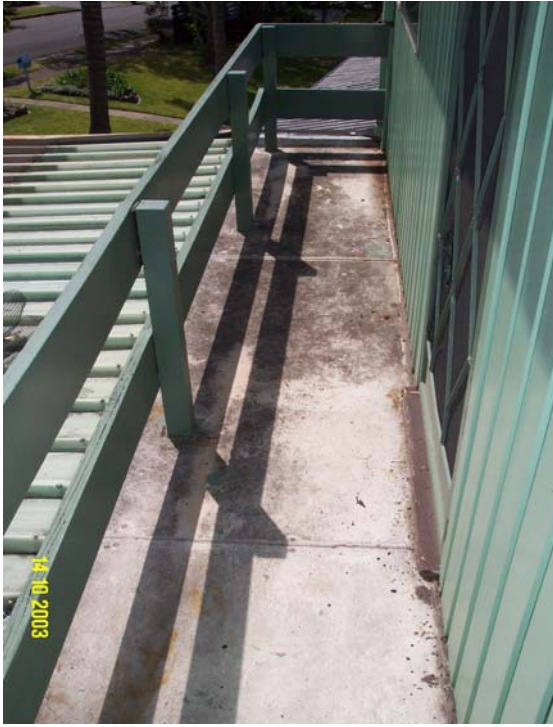
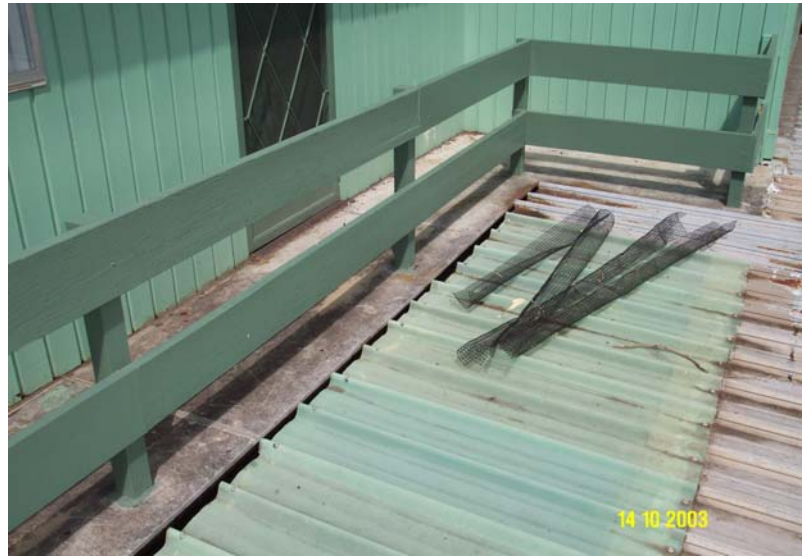
Before

This balcony had a problem with leaks, pooling water and being slippery when wet. We covered the internal gutter and sealed the water leaks. We then sprayed the entire area of the balcony, previous gutter area and 50mm up the walls of the house. We then added a fine aggregate for a slip resistant finish.
